Manhole Inspection Summary

Manhole # S41CC_064MH

Insp Date: **5/21/09 10:39 AM**

Location Address: **1407 ASHLAND**

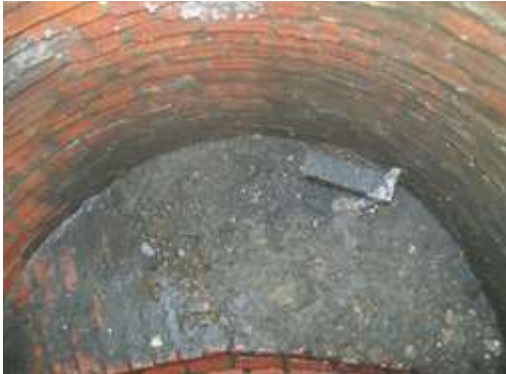
Defect 4

Condition: ☐ Sound ☐ Cracked ☐ Root Intrusion ☐ Deteriorated ☐ Leaks ☒ **Debris**

BENCH DEBRIS

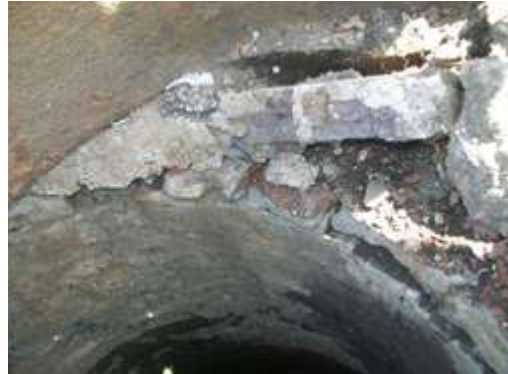
Defect 3

Condition: ☐ Sound ☐ Cracked ☐ Root Intrusion ☒ **Loose Brick** ☐ Deteriorated

CHIMNEY LOOSE/MISSING BRICKS

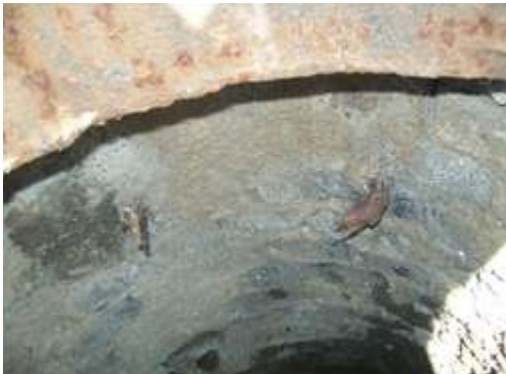
Defect 2

Steps Count: **5** Missing: **1** ☒ **Corroded**

STEPS MISSING/CORRODED

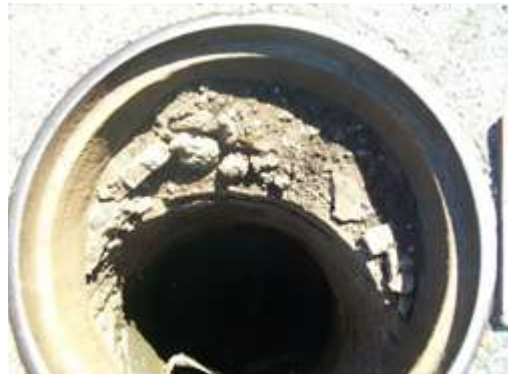
Defect 1

Frame Offset: **7** (in.) Condition: ☒ Sound ☐ Cracked ☐ Leaks

FRAME OFFSET

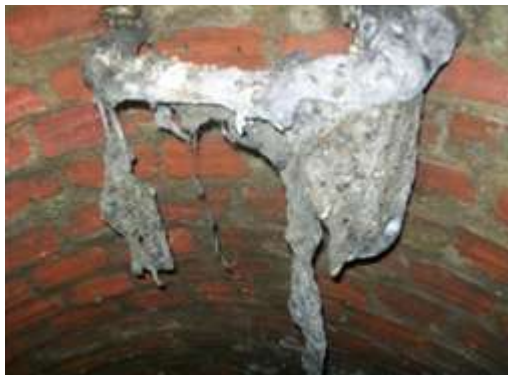
Defect 5

Surcharge ☒ **Evidence Of Surcharge** Depth: **4** (ft.) ☐ Active Surcharge Present

EVIDENCE OF SURCHARGE

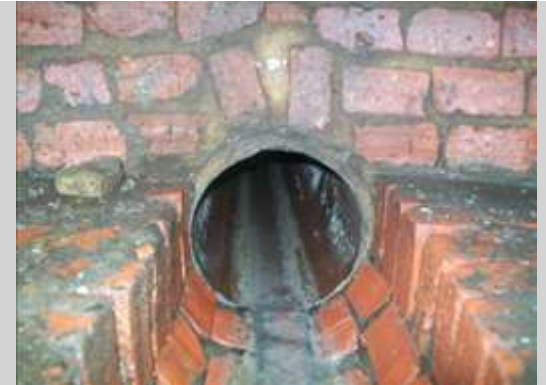
12 O'Clock Outflow

8 in. Circular Gravity Sewer
Pipe Out @ 12 O'Clock

Pipe Height: **8.4** (in.) Rod and Bar (Angled)
Pipe Material: **Clay** ☐ Pipe Lined
Invert Depth: **11.17** (ft.) Flow Characteristics: **Slow**
Deposits: ☒ None ☐ Mud ☐ Sludge ☐ **Debris** ☐ Grease
Silt Depth: **0** (in.) Deposits Extent:
Infiltration: **None** Pipe Seal Cond: **Sound**

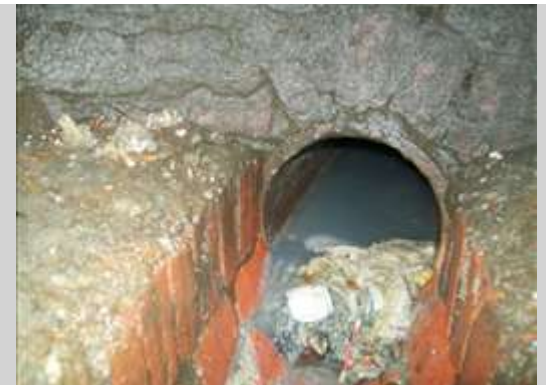
7 O'Clock Inflow

8 in. Circular Gravity Sewer
Pipe In @ 7 O'Clock

Pipe Height: **8.4** (in.) Rod and Bar (Angled)
Pipe Material: **Clay** ☐ Pipe Lined
Invert Depth: **10.92** (ft.) Flow Characteristics: **Slow**
Deposits: ☐ None ☐ Mud ☐ Sludge ☒ **Debris** ☐ Grease
Silt Depth: **3** (in.) Deposits Extent: **Medium**
Infiltration: **None** Pipe Seal Cond: **Unknown**
